Assessment of Dam Safety Coal Combustion Surface Impoundments (Task 3) Final Report

Big Rivers Electric
Corporation

Coleman Generating
Station

February 19, 2010

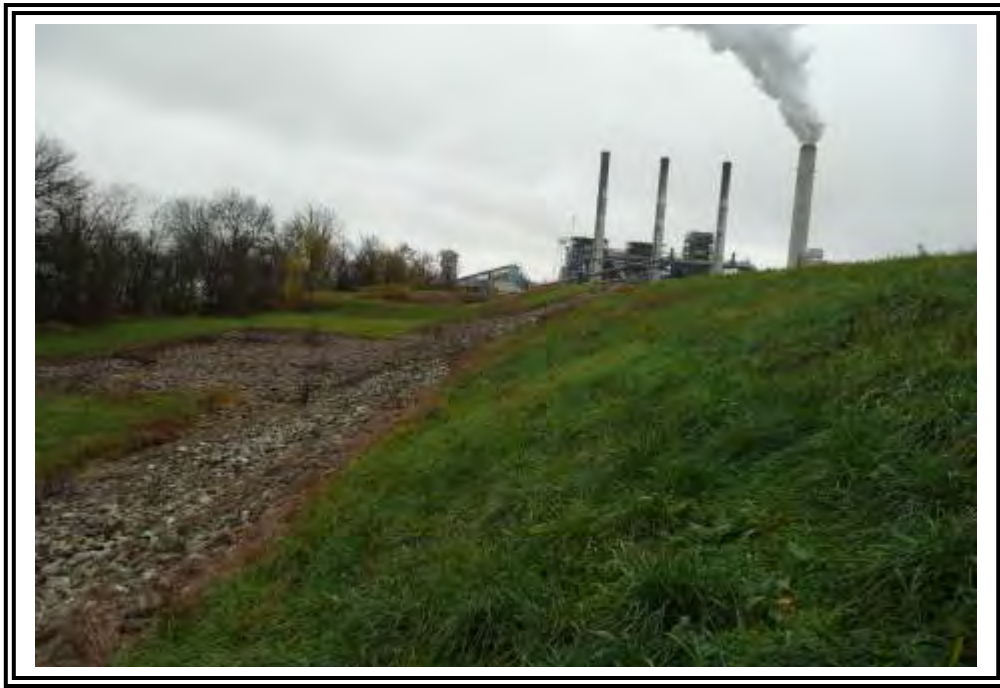
1

East dike outboard slope, looking south. Note rock toe drain.

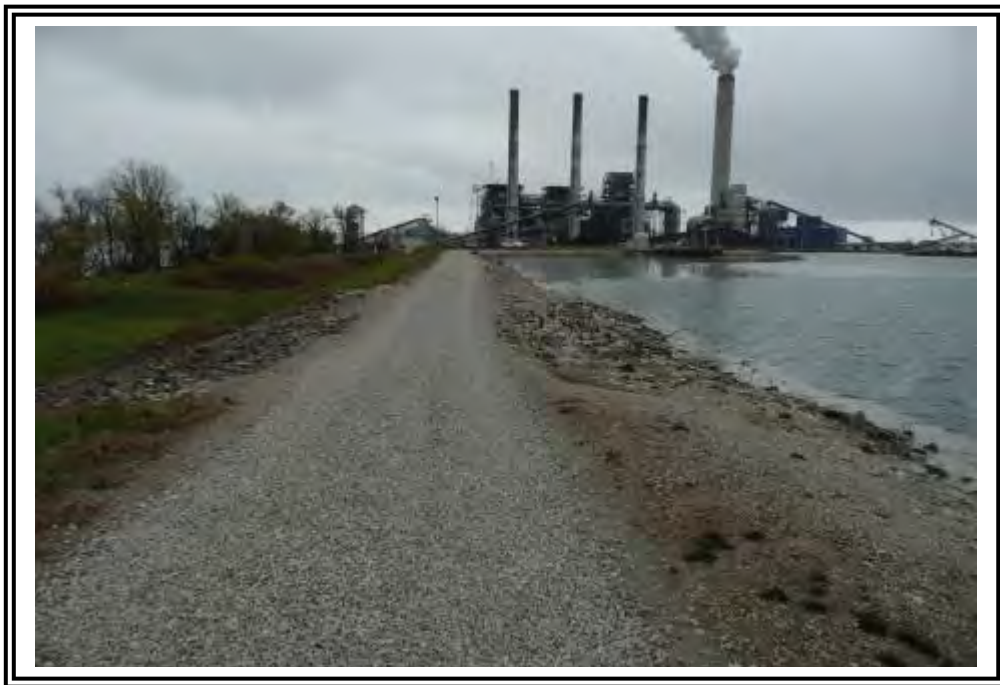
2

In general, the Ash Pond A dikes do not show signs of changes in horizontal alignment from the designed alignment (Photos 2, 8, 13, 14). The crest areas supported a granular surfaced access drive to service the impoundment. These appeared stable and free from any abrupt gross vertical deformation or cracking. In some areas the embankment crest areas were overbuilt due to ash handling processes, and a build-up of ash could be observed, making the crest area wider than initially designed (Photo 14). This was particularly evident along the western and central portions of the south dike, and to a somewhat lesser extent along the west dike and the western portion of the north dike. Isolated areas of softened surface gravel and bird baths were also observed on the south dike crest as well (Photo 16).

East dike crest, looking south. Note gravel crest surface.

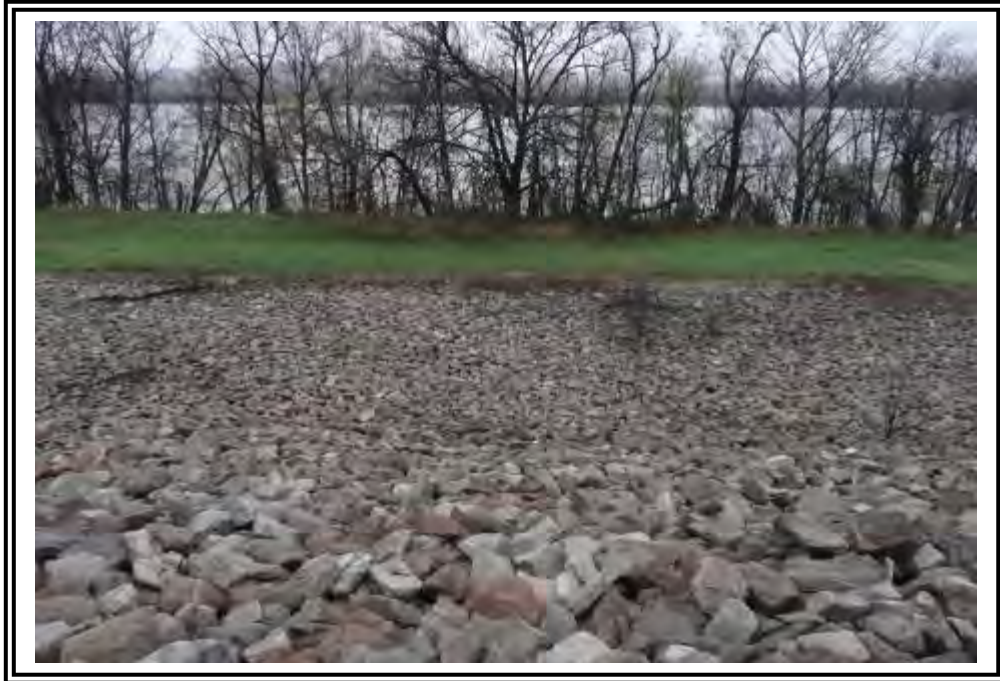
3

armoring was observed from the crest to the toe. This is the area of the emergency spillway (Photo 3).

East dike emergency spillway, looking east toward the Ohio River. Note isolated dying woody vegetation.

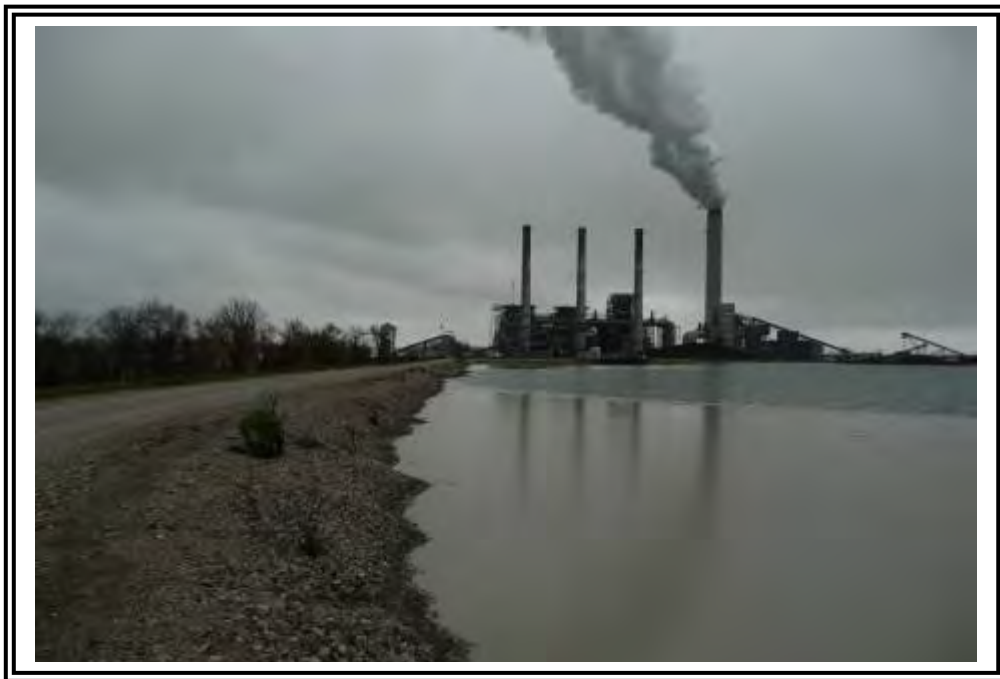
4

Inboard slope areas of the impoundment were generally rock or ash covered (Photos 4, 9, 13, 14, and 17). As a result of grading activities, looser materials had been pushed out on these slopes, making them susceptible to erosion rills in locations where surface runoff has become concentrated (Photos 10 and 18). These areas were also susceptible to beaching erosion, particularly in the western portion of pond. Available freeboard appears to be on the order 1.5 to

East dike inboard slope with rock surface, looking south. Note isolated woody vegetation.

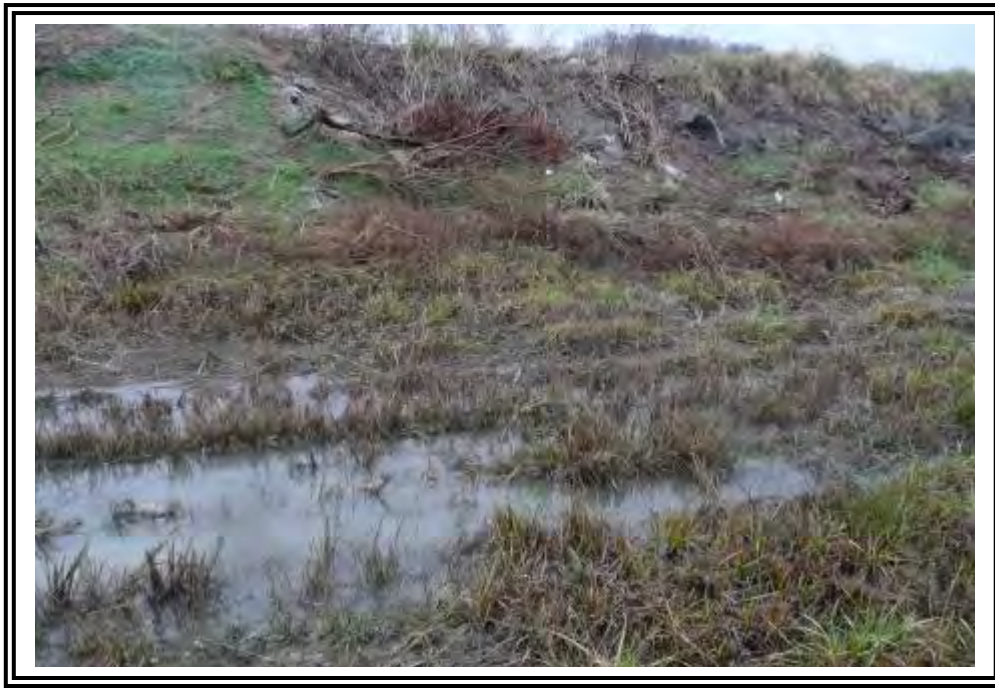
7

Standing water was also observed at the toe area of the north dike. In this area however, in addition to the recent precipitation, the standing water was the consequence of a drainage culvert beneath an access drive being crushed and completely covered (Photo 7). This has blocked the culvert and apparently allowed standing water to build up in this area for a period of time. In this area the soil at the base of the drainage swale had begun to soften, allowing a probe to penetrate approximately 1 foot.

Poor drainage at toe of north dike where culvert under road has been blocked.

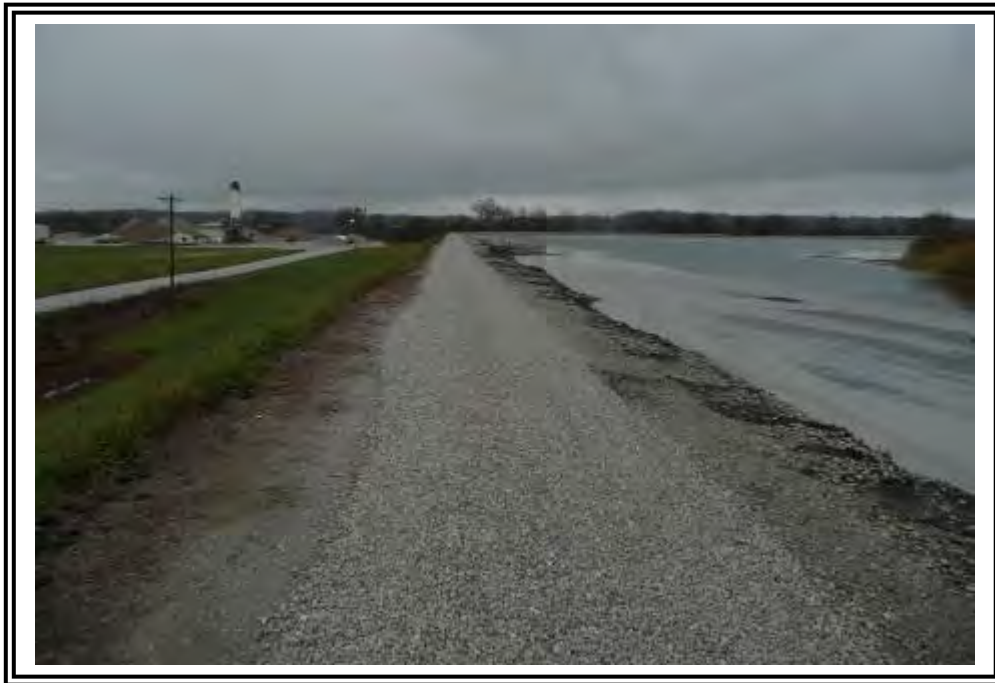
8

North dike crest looking east. Note wet area at toe of dike to left of photo.

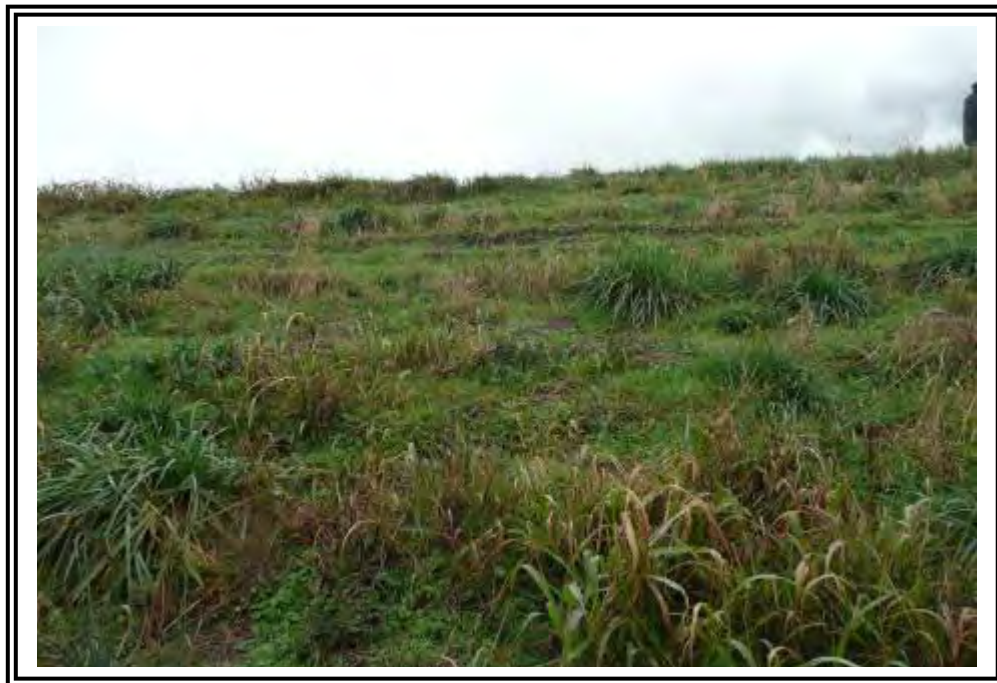
12

Mowing ruts on west dike outboard slope.

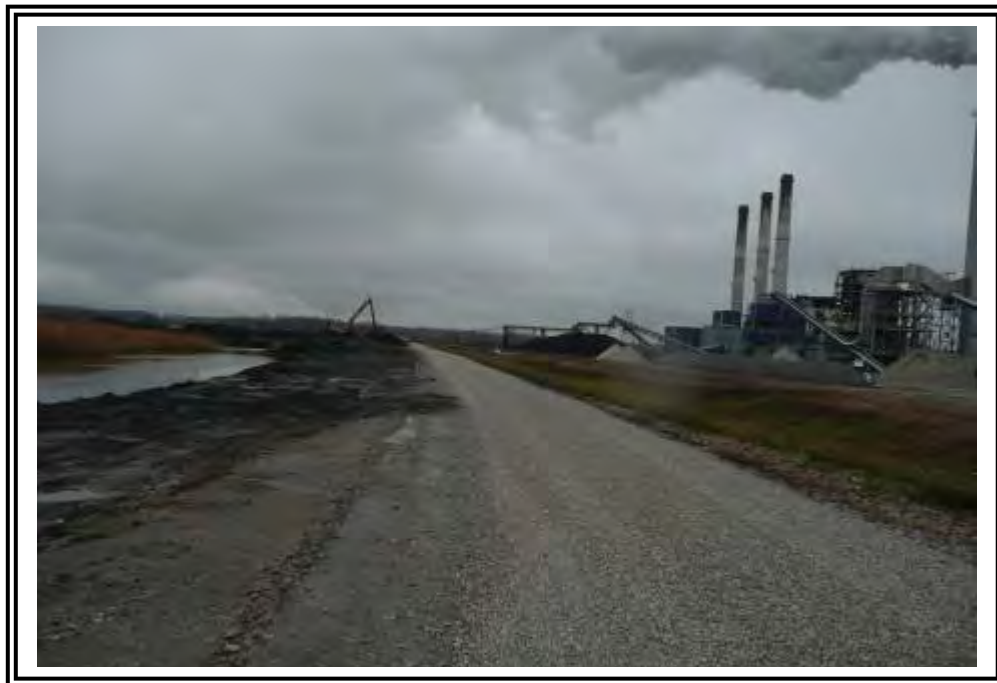
14

South dike inboard slope and crest at ash processing area, looking east.
Note buildup of ash on inboard slope that widens crest area.

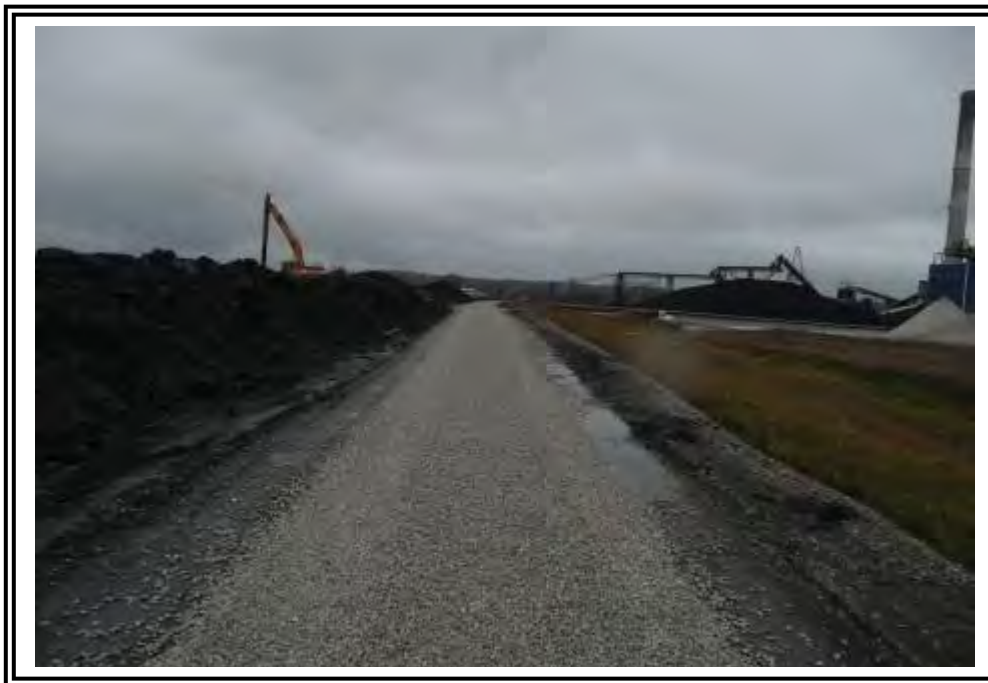
16

South dike crest looking east. Note standing water in puddles.

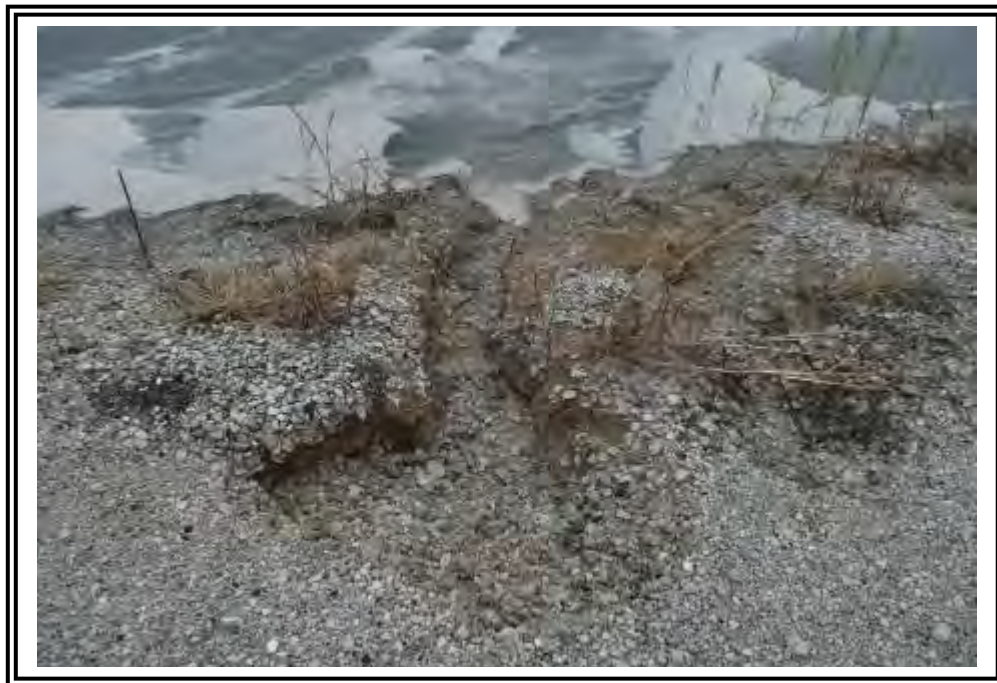
18

Erosion rills on inboard slope of south dike.

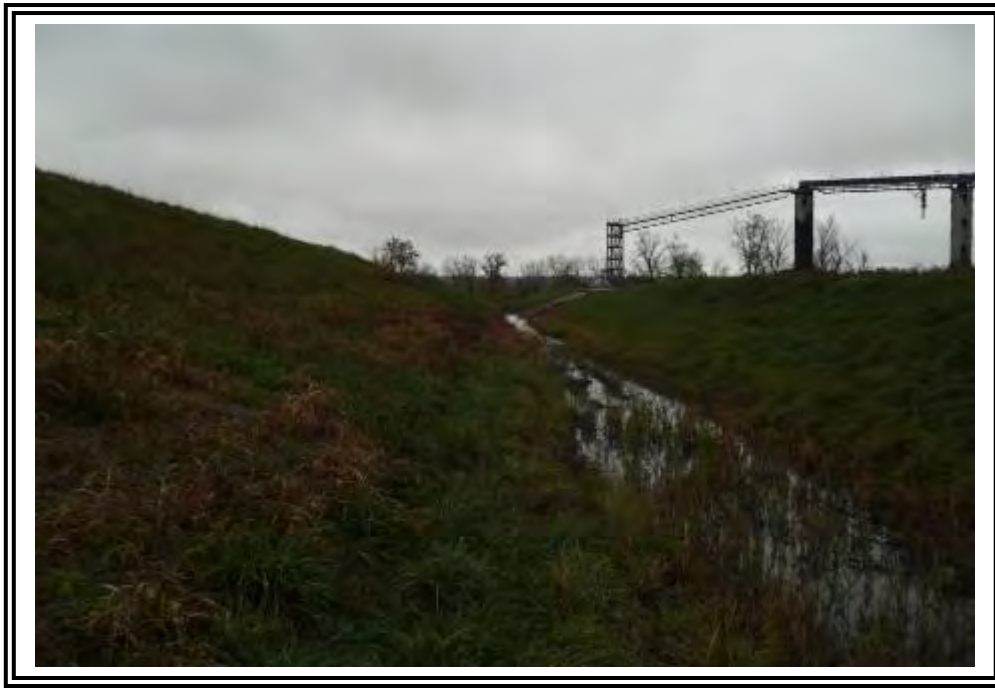
19

An access ramp for ash processing equipment and pond maintenance was observed on the south dike outboard slope. Ash sluicing lines and other waste water pipelines emptying into the pond were also noted on this ramp. In the portion of the dike north of this access ramp, standing water was observed at the dike toe in a drainage swale. This appeared to be due to precipitation before and during the site visit in addition to possible poor drainage (Photo 19).

Standing water in drainage swale at toe of south dike.

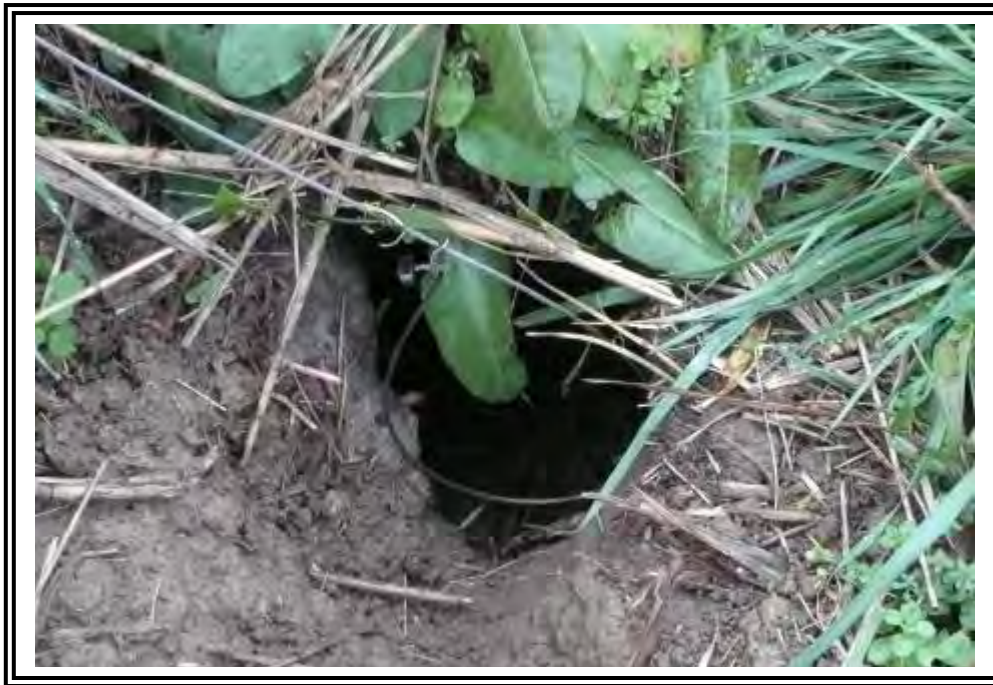
21

Rodent burrow with trap.

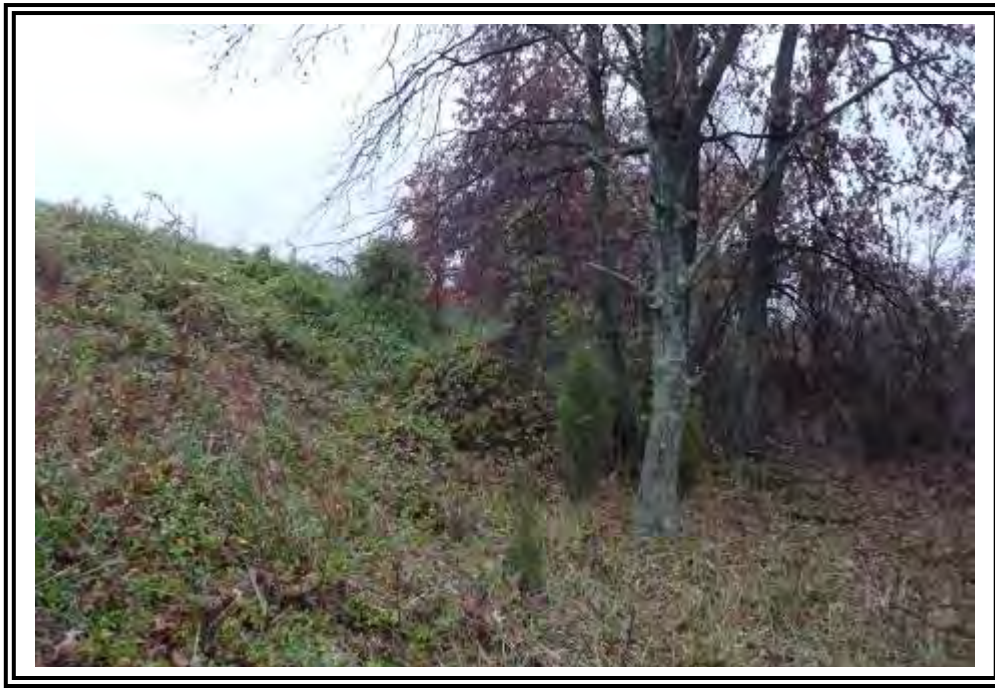
27

South dike outboard slope, looking east.
Note trees and brush vegetation on slope and at slope toe.

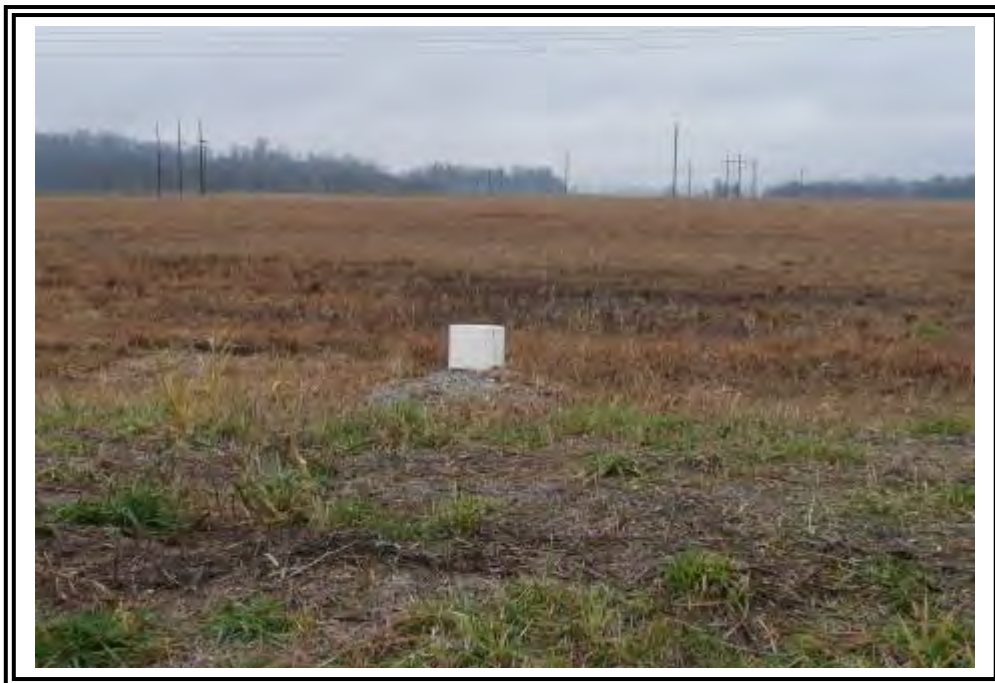
28

The primary outlet structure is a 24-inch diameter PVC riser connected to a 24-inch diameter PVC pipe located along the south dike (Photo 28). This pipe conveys water beyond the dike toe to the upper portions of the drainage feature running parallel to the south dike, eventually emptying into the Ohio River. At the time of the site assessment, the pond was dry and the outlet was inactive. It appeared to be open and unobstructed, with rip rap outlet protection. Sporadic dead or dying vegetation was observed in the outlet protection (Photo 29).

Outlet riser in pond area.

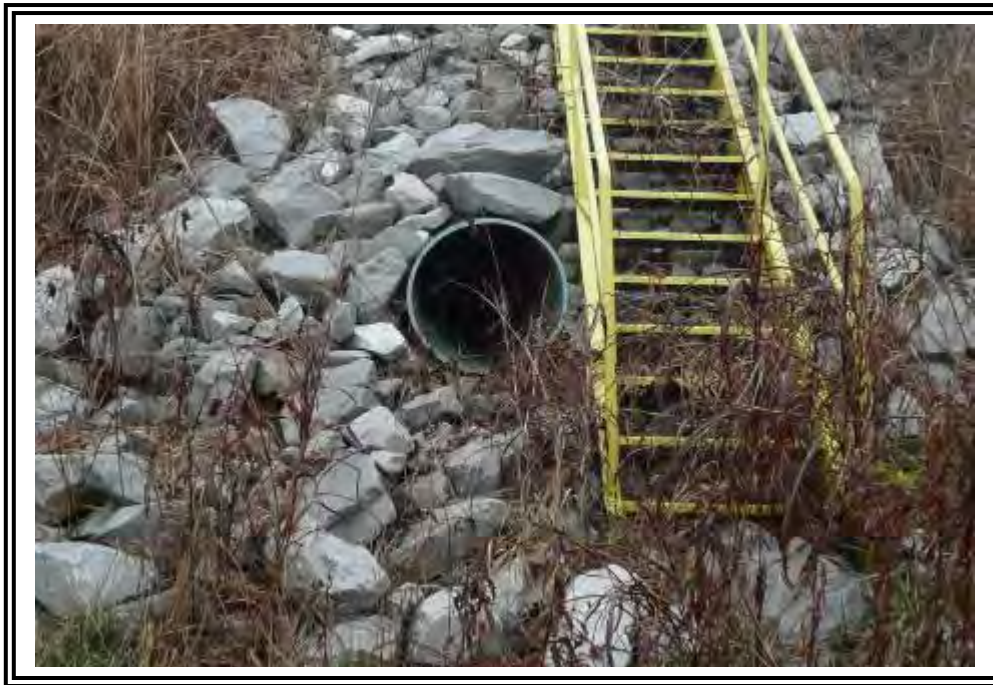
29

Outlet pipe on south dike.

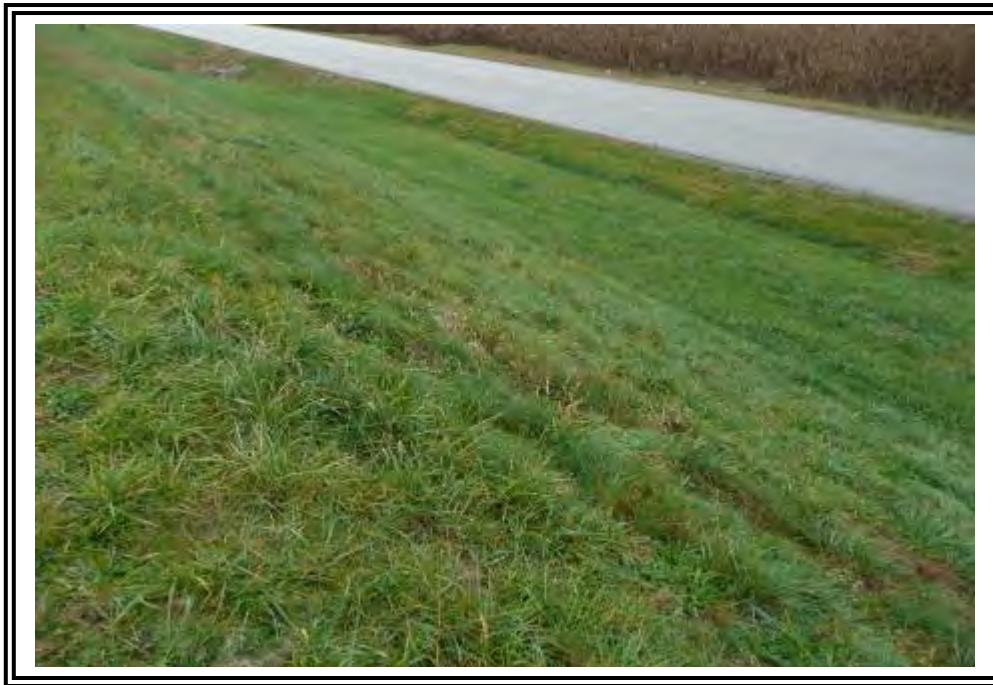
39

Mowing ruts in surface on west dike outboard slope.

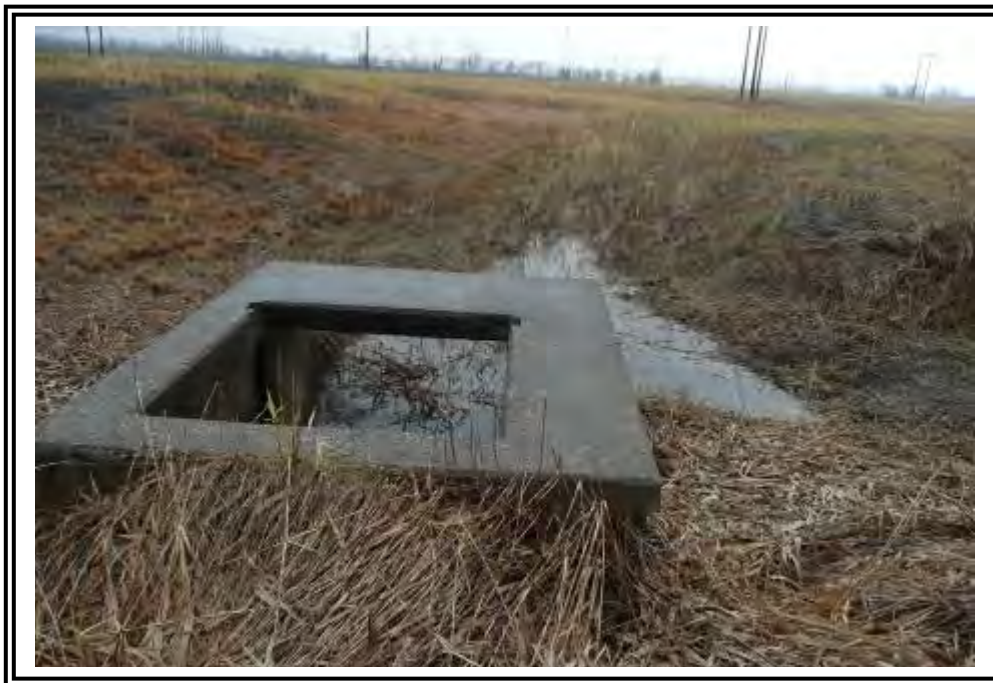
42

A secondary outlet is a roughly 9-foot by 12-foot reinforced concrete spillway riser located on the north dike (Photo 42). This structure is connected to a 48-inch diameter reinforced pipe and conveys water to a sump pit in the area where the old North Ash Pond was reclaimed (Photo 43). Effluent collected in this sump is pumped to Ash Pond A. This structure is configured to accept stop logs to control the pond level; however this structure is no longer actively controlling a water level. During the site visit, the ash level and dried ground surface was generally observed to be above this structure. Furthermore, this area had been graded so that drainage swales from the pond area could convey water to this location when dredged ash was being dewatered and promote positive drainage for stormwater runoff. Water was noted pooling against this structure and dead or dying weedy vegetation was encountered at the structure opening. This vegetation did not appear to be impeding the structure in its present function.

Old outlet structure to closed and reclaimed North Pond.
